Forest Service Manti-La Sal National Forest Ferron/Price Ranger District Ferron Work Center 115 West Canyon Road

I am sending you a compact disc (CD) with inspection reports and photographs from the Pines/Muddy area and Starpoint Springs on the Manti-La Sal National Forest. This is for the purpose of information-sharing between our agencies.

On Tuesday May 10 I went to the Emery allotment to check the condition of the range and Range improvements, the grass was just starting to "green up" brome was between 2 to 5 inches tall and the poa was only about an inch tall. The road was still damp but not muddy. The first improvement I inspected was 'Verdus Pond" It still had a small snowbank on its west side (see Picture #1) and a small puddle of water in the bottom but just east of center there is a large crack in the bottom (see Picture 2-6) and there is evidence of large amounts of water flowing into the crack instead of being stored in the pond. (see picture 7) Directly south of Verdus pond and across the road there was a puddle of water approximately 12 feet across and 4-6 inches deep.(see picture 8) This tells me that there would have been more water in the pond if it did not have

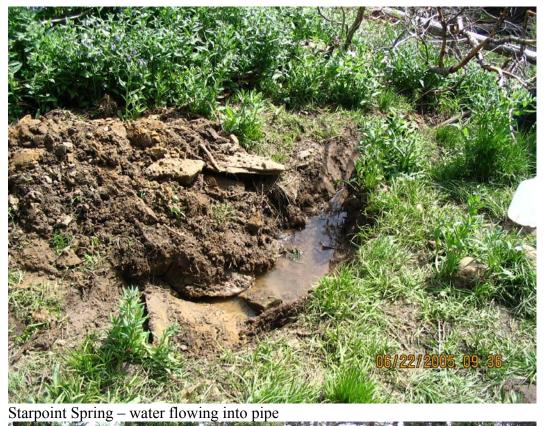
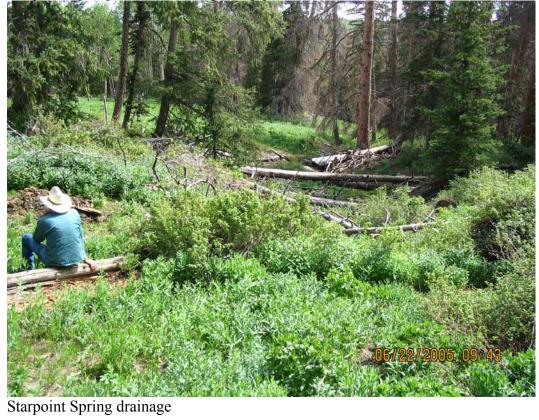
25. LIST CONTRACT PAY	MENTS, REPORTS, CORRESPONI	DENCE, ET	C.	26. WOR	KERS ON SITE			N	lumber	
<u>It</u>	<u>tem</u> <u>F</u>	Prep	Submit		Cla	ssification	ſ	PRIME	SUB	
	IDED SERVICES ADEQUATELY AN	ND TIMELY	,							
YES  28. NARRATIVE REPORT	☐ NO - Explain in narrative									
	int Spring was made by	Cathy	Dodt-I	Ellis. To	m Llovd. I	Dennis Ware	Plateau	Mine), a	nd Lee	
	tee) on 06/22/05. Den									
	g into the damp depres									_
	a and measured 1 pint									•
	t per 15 seconds. It						_	=		
_	urated with water from						_	_		
_							_			L
	nd the spring depressi									
	blish the spring was d									
	is issue would be reso			_						
	ently emerging from ab									
	if it continues to flo	w or no	t. P.	lateau Mi	ne will ap	oproach manag	gement wi	th the p	roposal	
to re-establish t	he spring.
